**DEBRIS/ICE/TPS ASSESSMENT and
INTEGRATED PHOTOGRAPHIC ANALYSIS
OF SHUTTLE MISSION STS-108**

Armando Oliu
Process Engineering/Mechanical System Division/ET-SRB Branch,
Kennedy Space Center, Florida

December 5, 2001

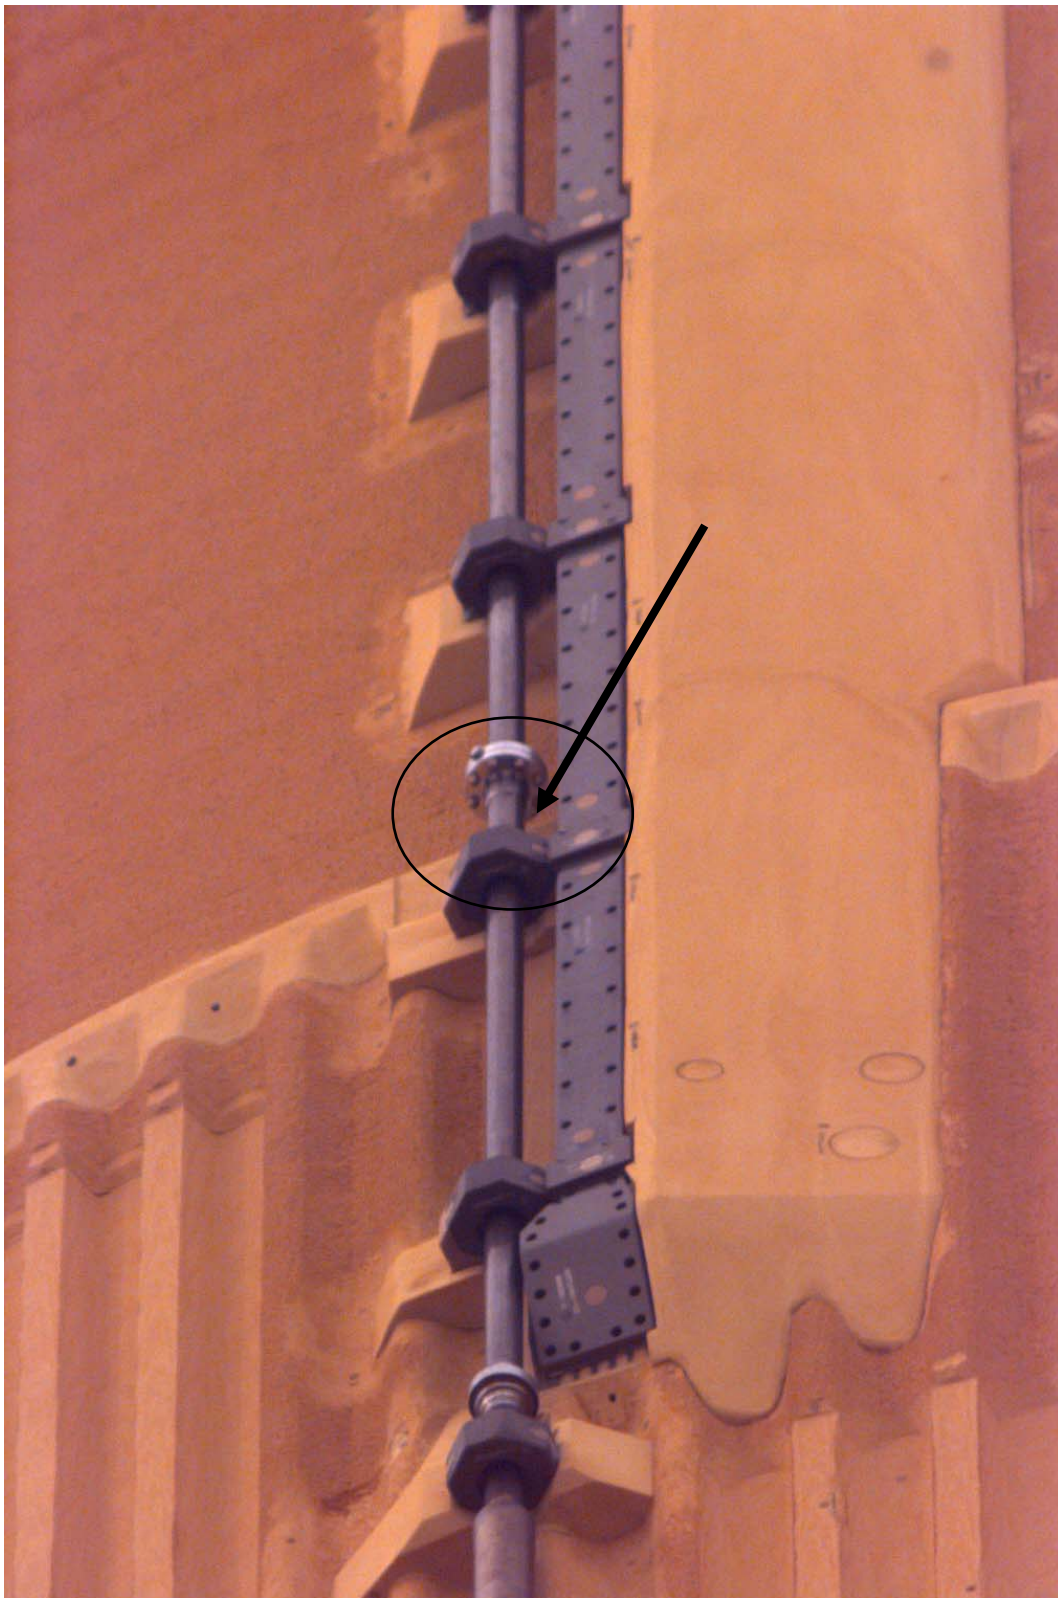
After the pre-launch inspection, but before start of propellant loading, PR-ET-TS-0018 was initiated during operation OMI T6446 to document damaged ET TPS. The crushed foam was located under the GO2 pressurization line at Xt-852. The area measured 1-1/2 inches in diameter, with a depth of 1/4-inch. Since the area where the damaged foam was located has underlying foam of approximately 4-inches thick, the PR was dispositioned to use-as-is, with Material Review Board (MRB) approval.

Photo 2: Area of damaged ET TPS under GO2 Pressurization line
PR-ET-TS-0018 was initiated to document crushed foam.

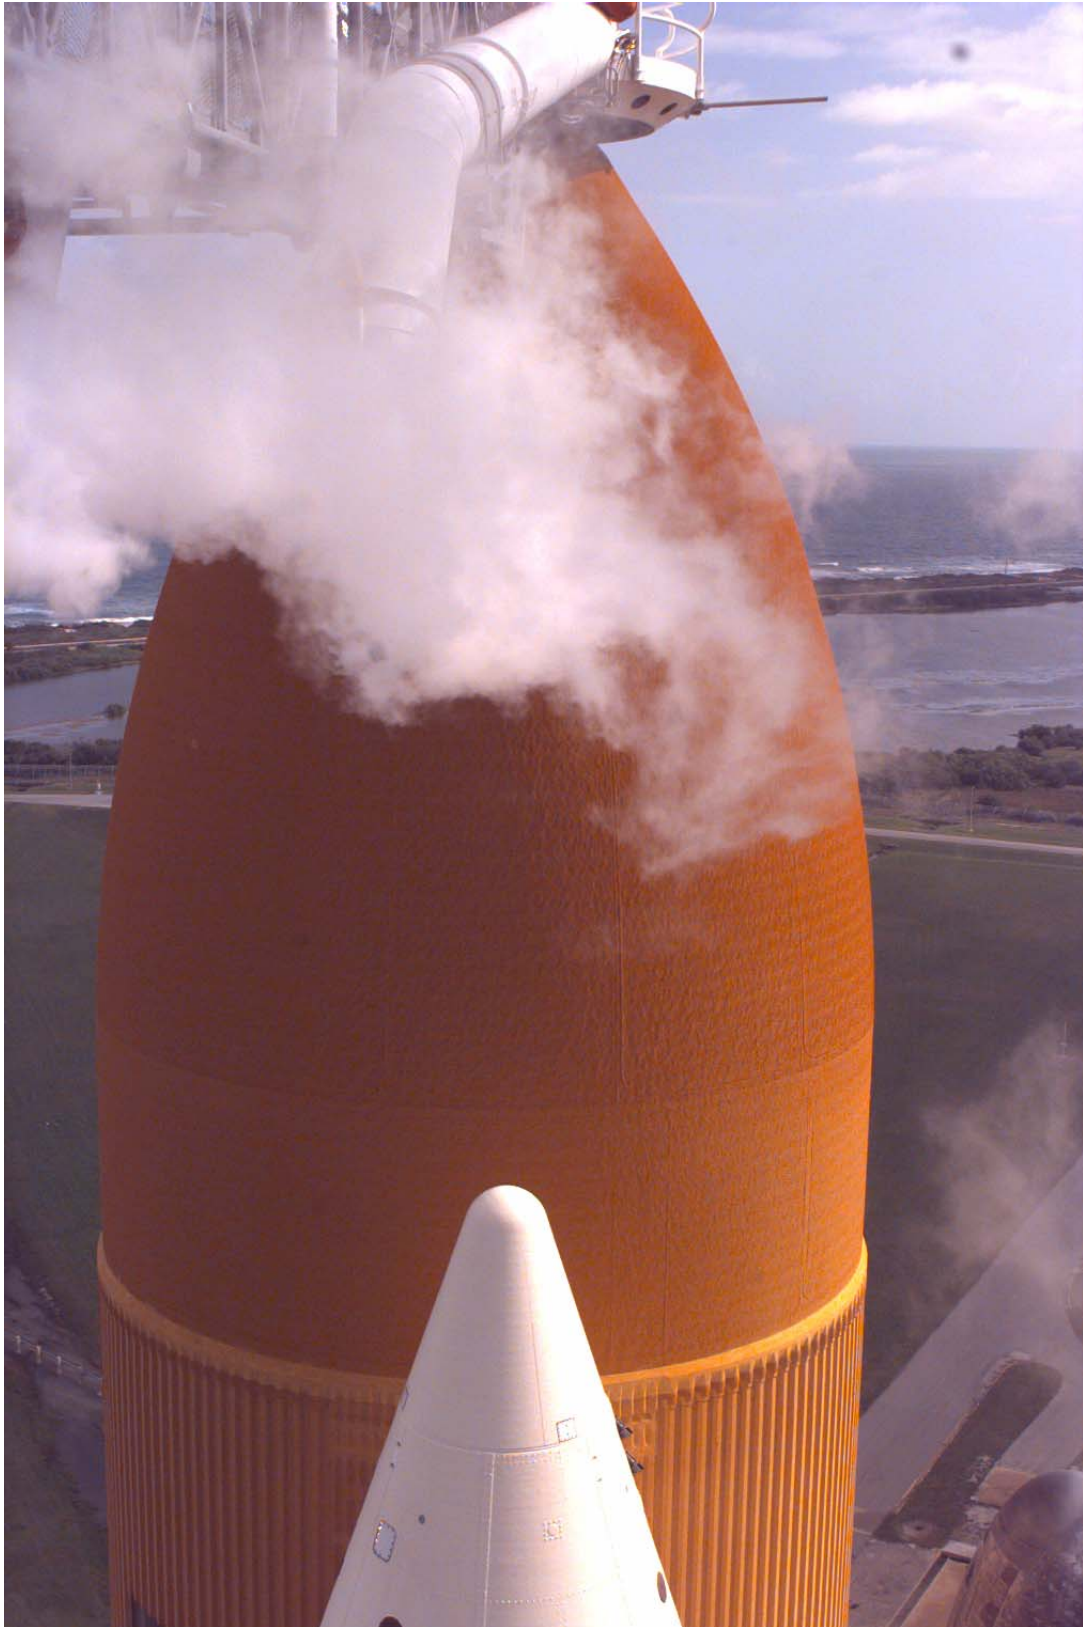
Photo 3: LO2 tank acreage.

Very little condensate was present on the LO2 tank acreage. Surface temperature ranged from 57-75 degrees Fahrenheit. There were no acreage TPS anomalies.

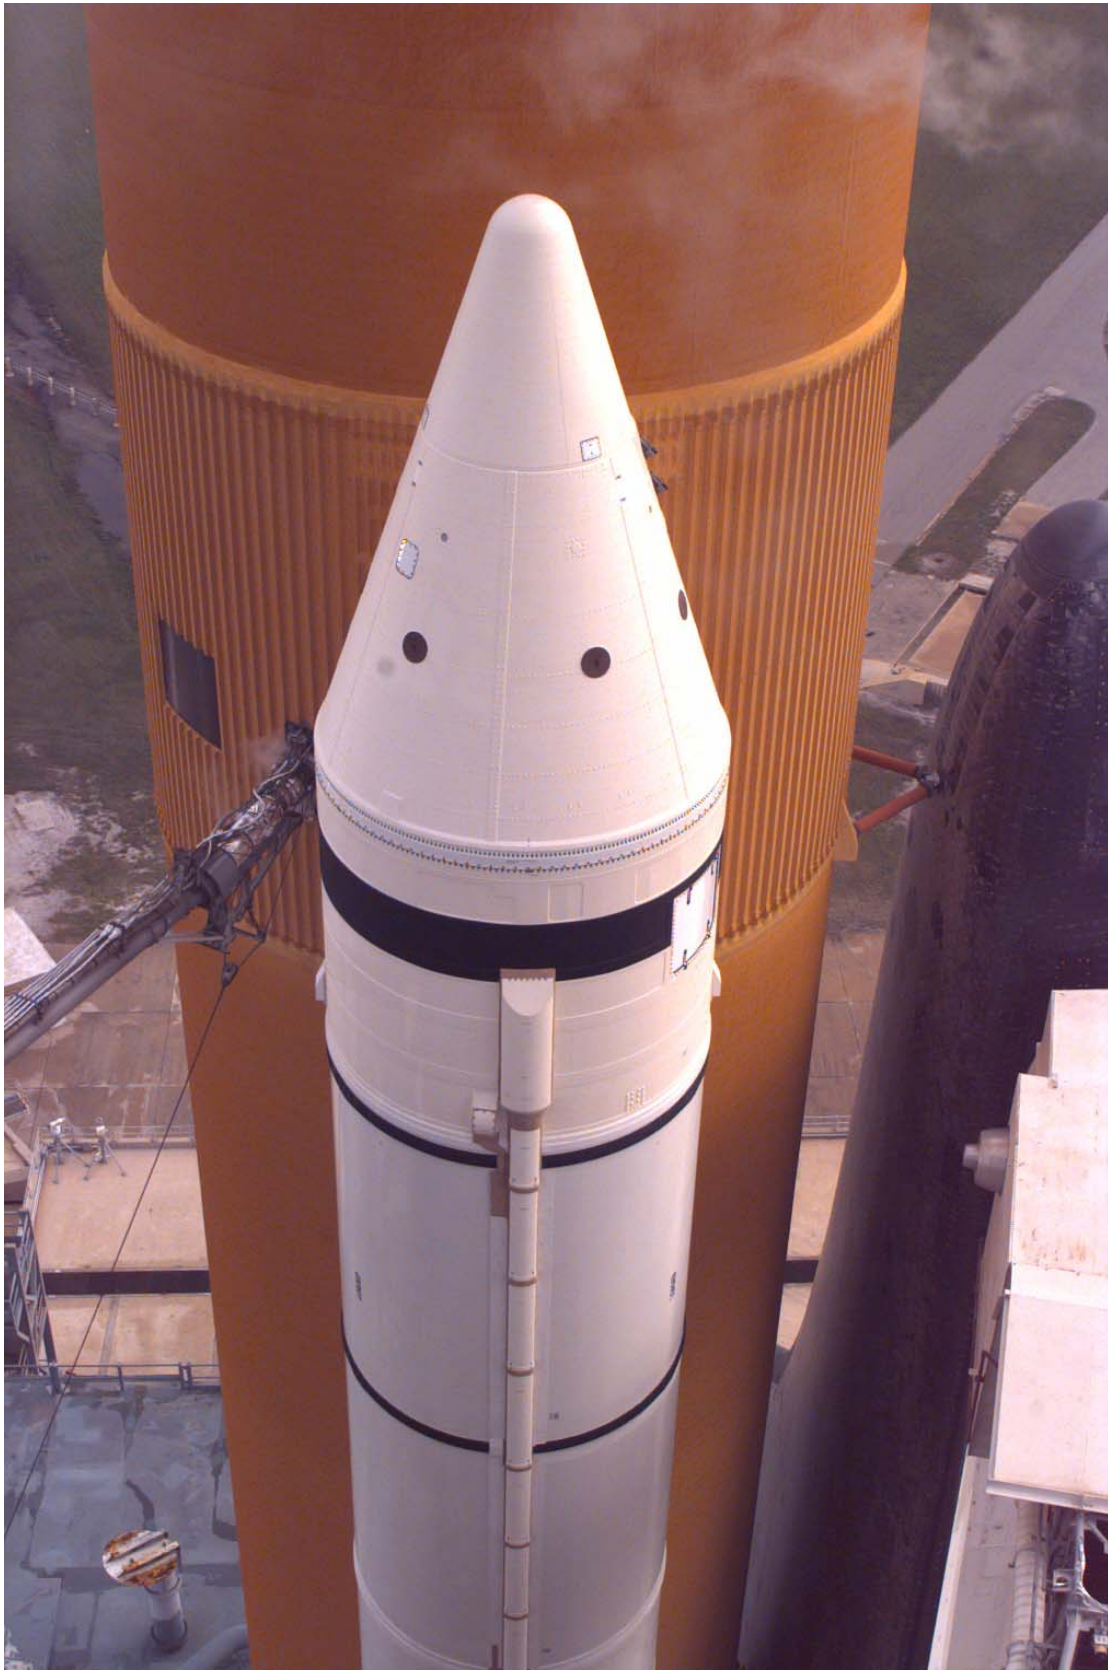
Photo 4: LH2 tank acreage.

The LH2 tank was wet with moderate condensate on the upper portion and significantly more condensation at the aft end. Surface temperature ranged 59 to 78 degrees Fahrenheit. There were no acreage TPS anomalies.

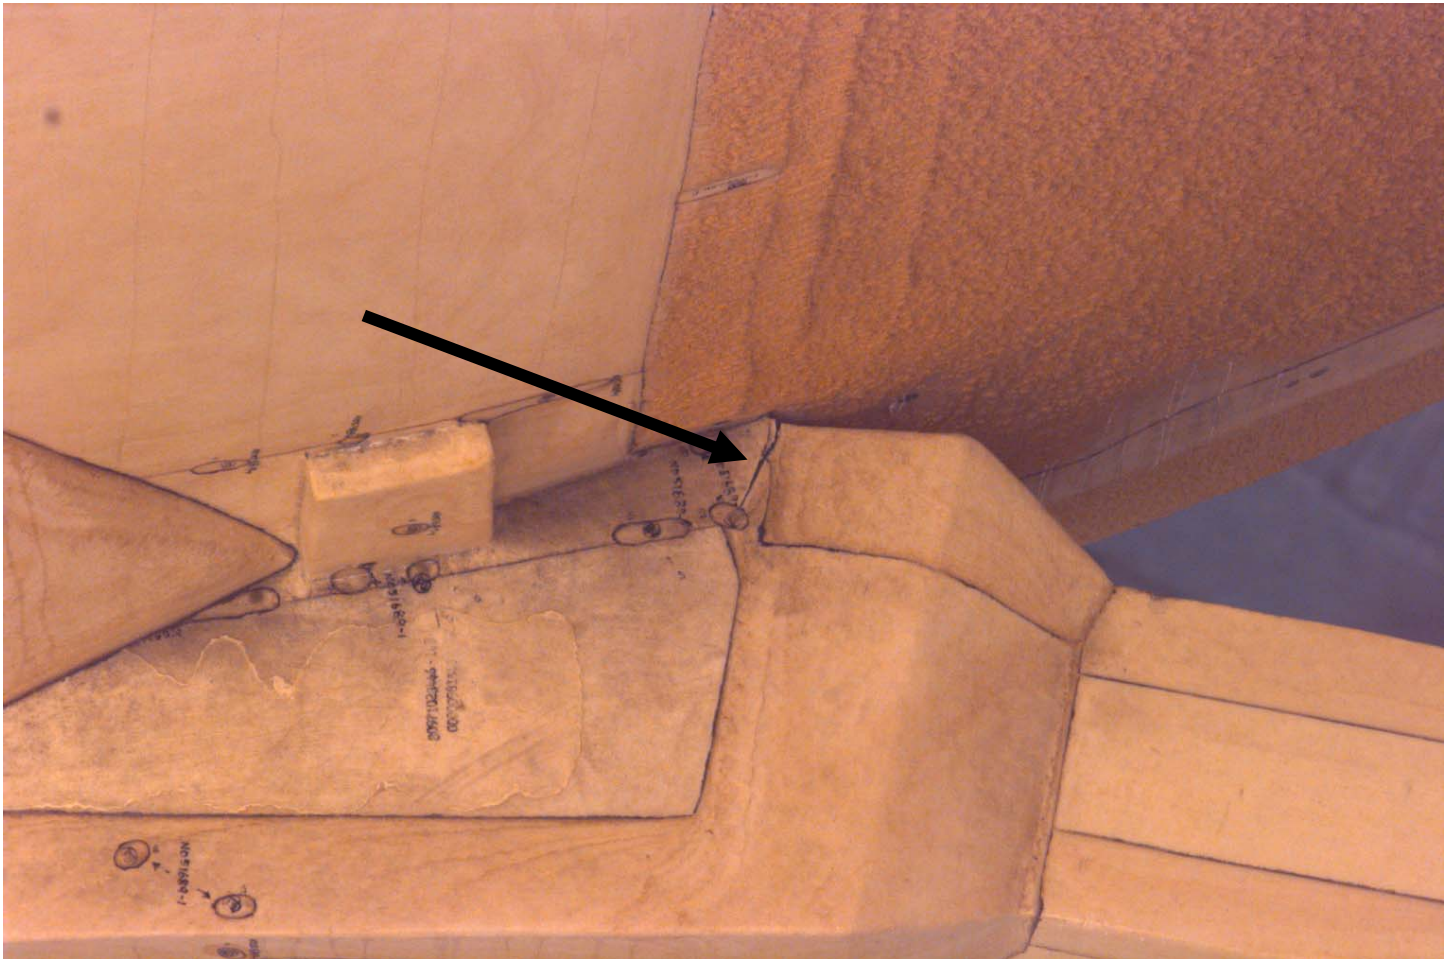
Photo 5: Crack in -Y Vertical Strut TPS

A 2-1/2 inch long and 1/8 inch wide stress relief crack was observed in the -Y vertical strut TPS with no offset. This condition has been observed on previous vehicles and found acceptable for flight per the NSTS-08303 criteria.

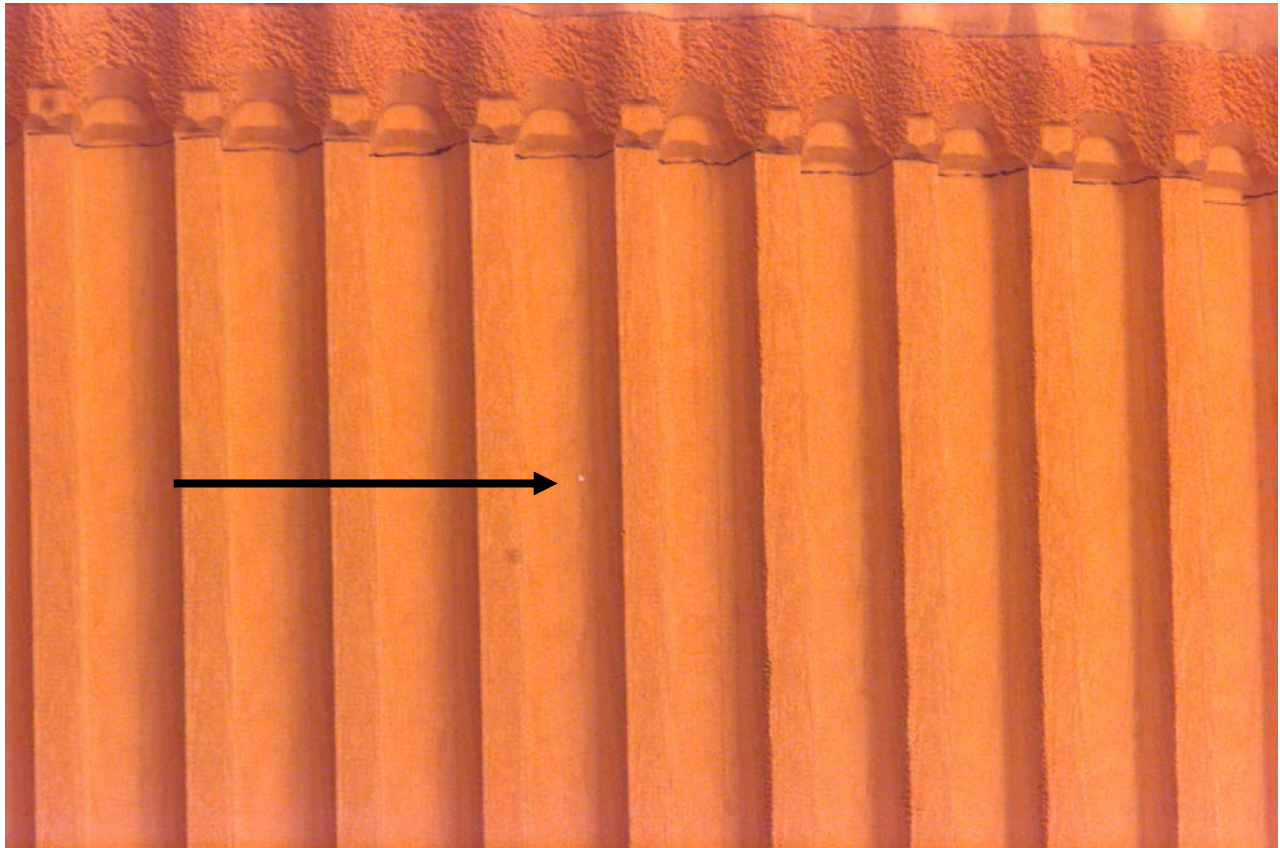
Photo 6: Frost spot over fastener location in intertank valley.
One of four frost spots observed above fasteners.

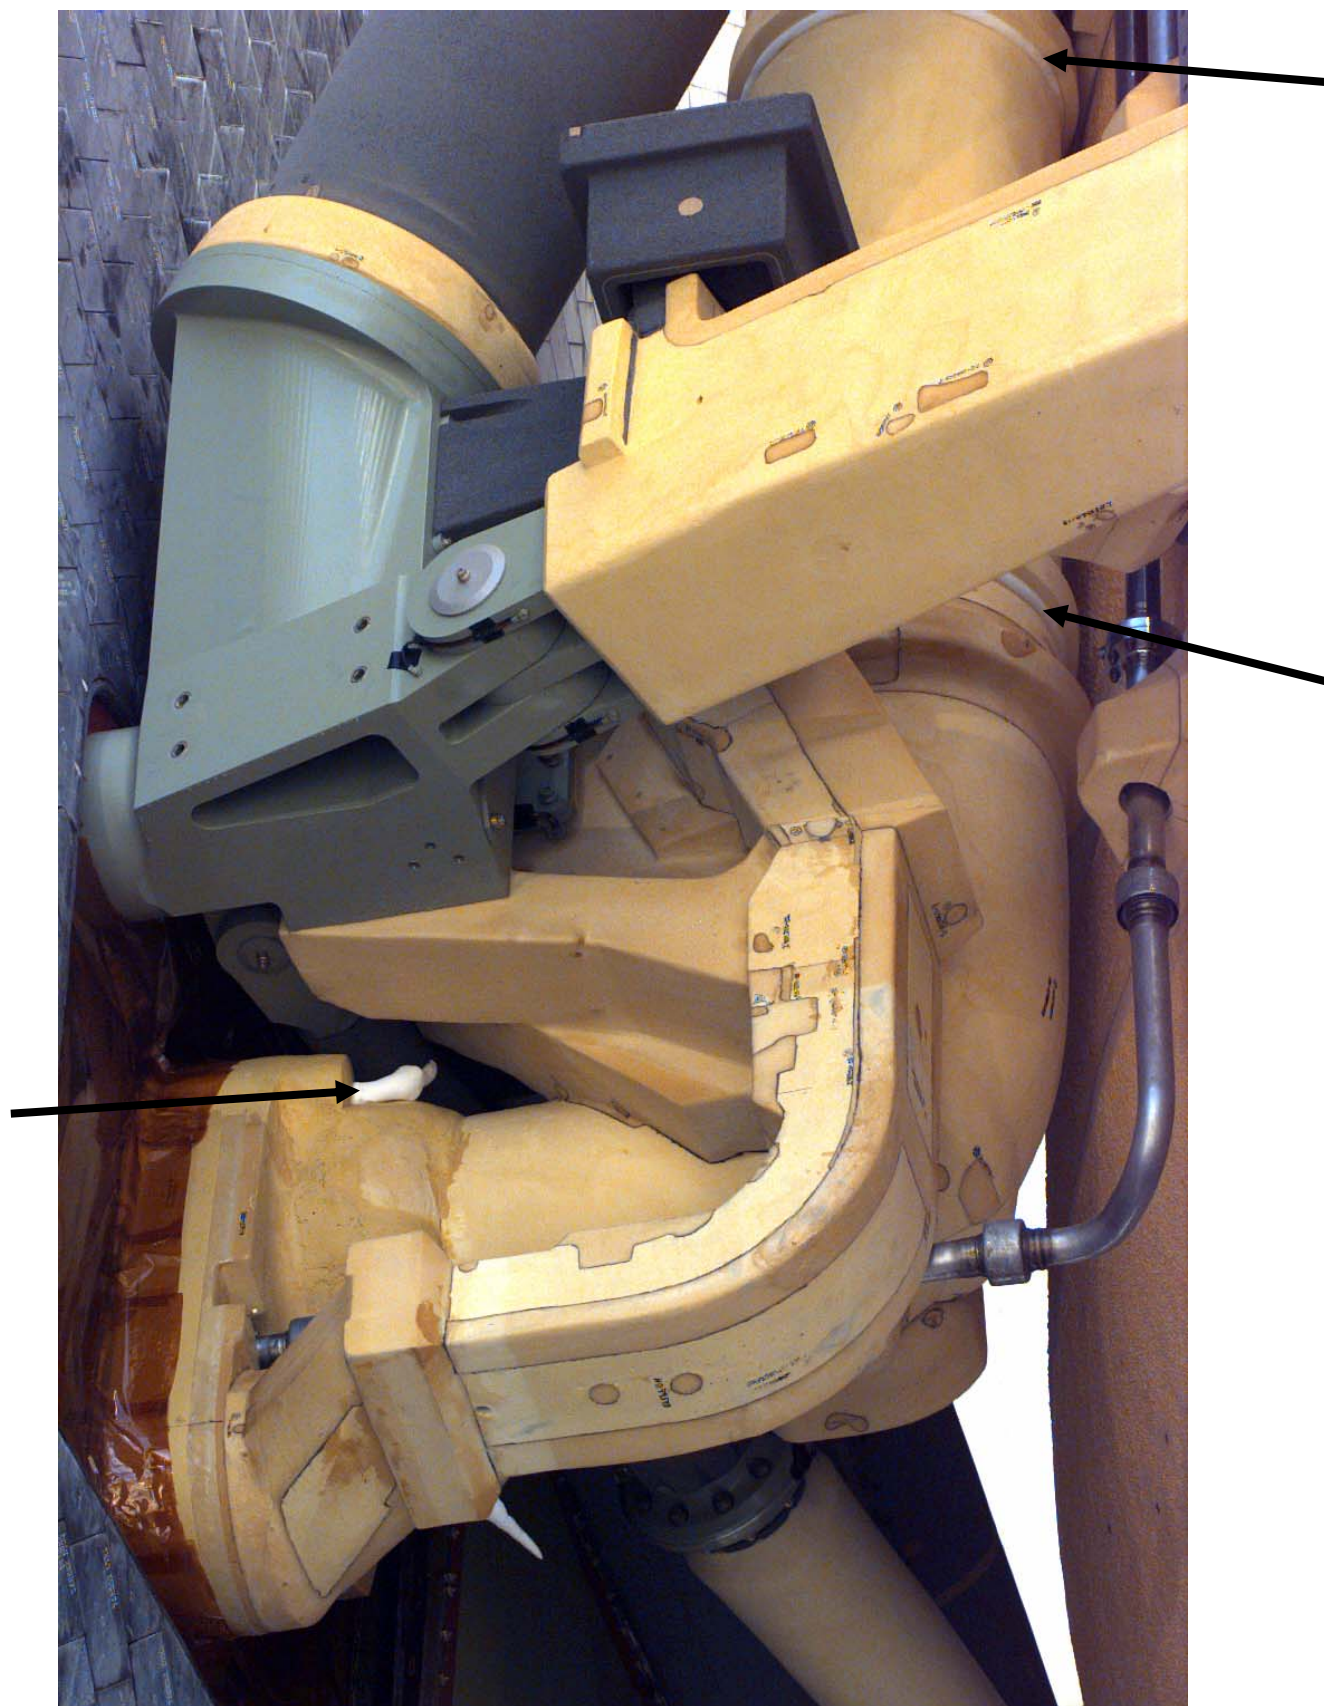
Photo 7: LO2 Umbilical area.

Typical ice/frost finger on pyro canister vent and on LO2 feedline bellows.

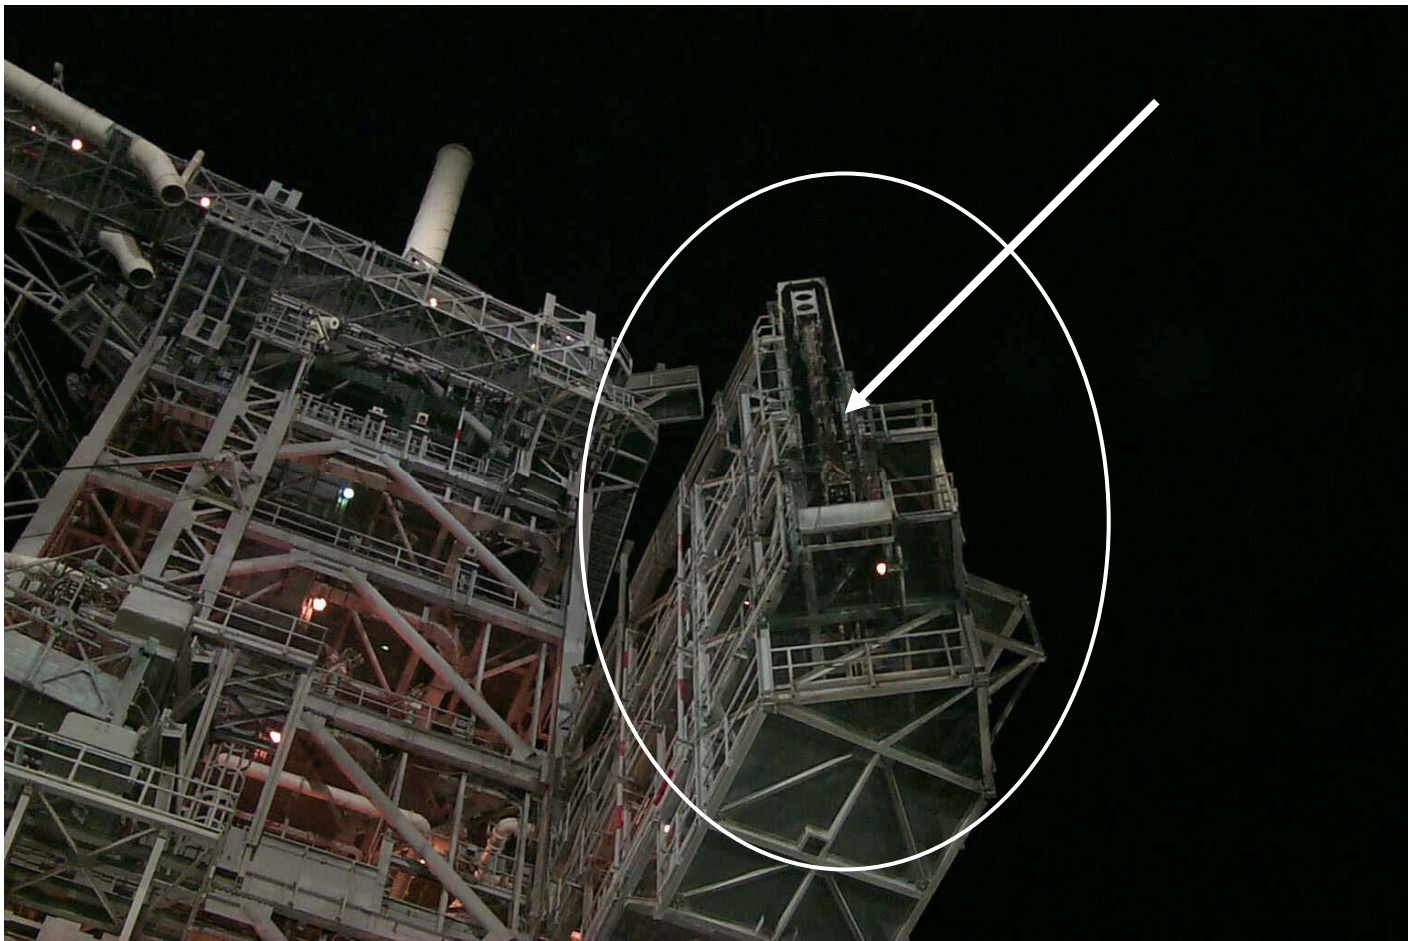
The GH2 vent line did not latch on the FSS latching mechanism. It appears the vent line impacted the south side of the FSS structure preventing the latch back and caused substantial damage to the saddle structure. The south side bridle cable sheared from the southern tang on the yoke. Pieces of debris (bolts and clevis leg) were found on/in the grating and vent line structure. The GUCP sustained minor damage from the vent line impact with the FSS. The 7-inch QD exhibited no damage and the poppet was observed to be intact. The deceleration cable was in nominal configuration, and the vent line blanket was sooted and torn.

Photo 8: Overall view of GH2 vent line haunch on the FSS post launch.

GH2 vent line struck the FSS and failed to latch back.

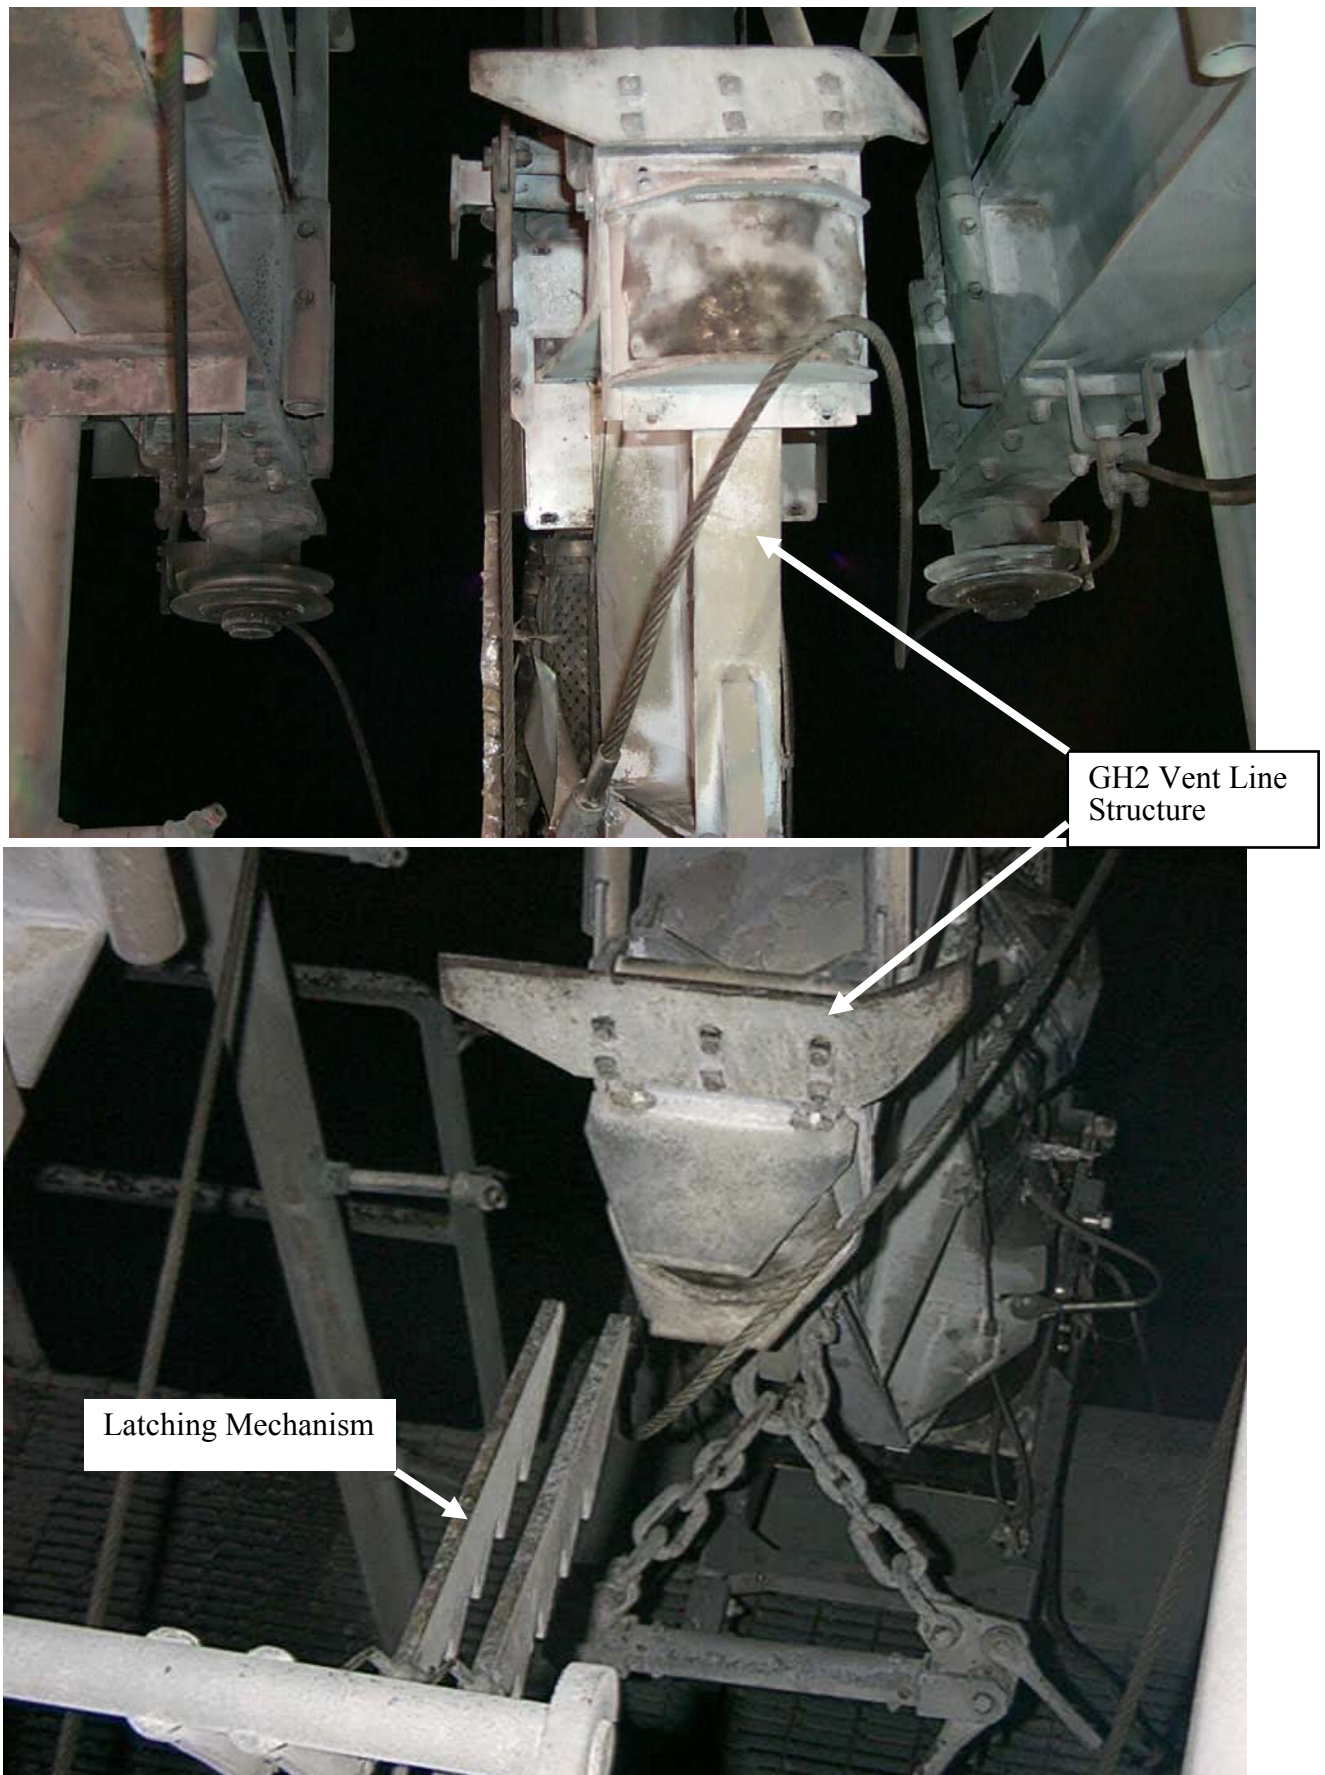
Photo 9: Detail view of some of the damage sustained by the GH2 vent line after impact with FSS.

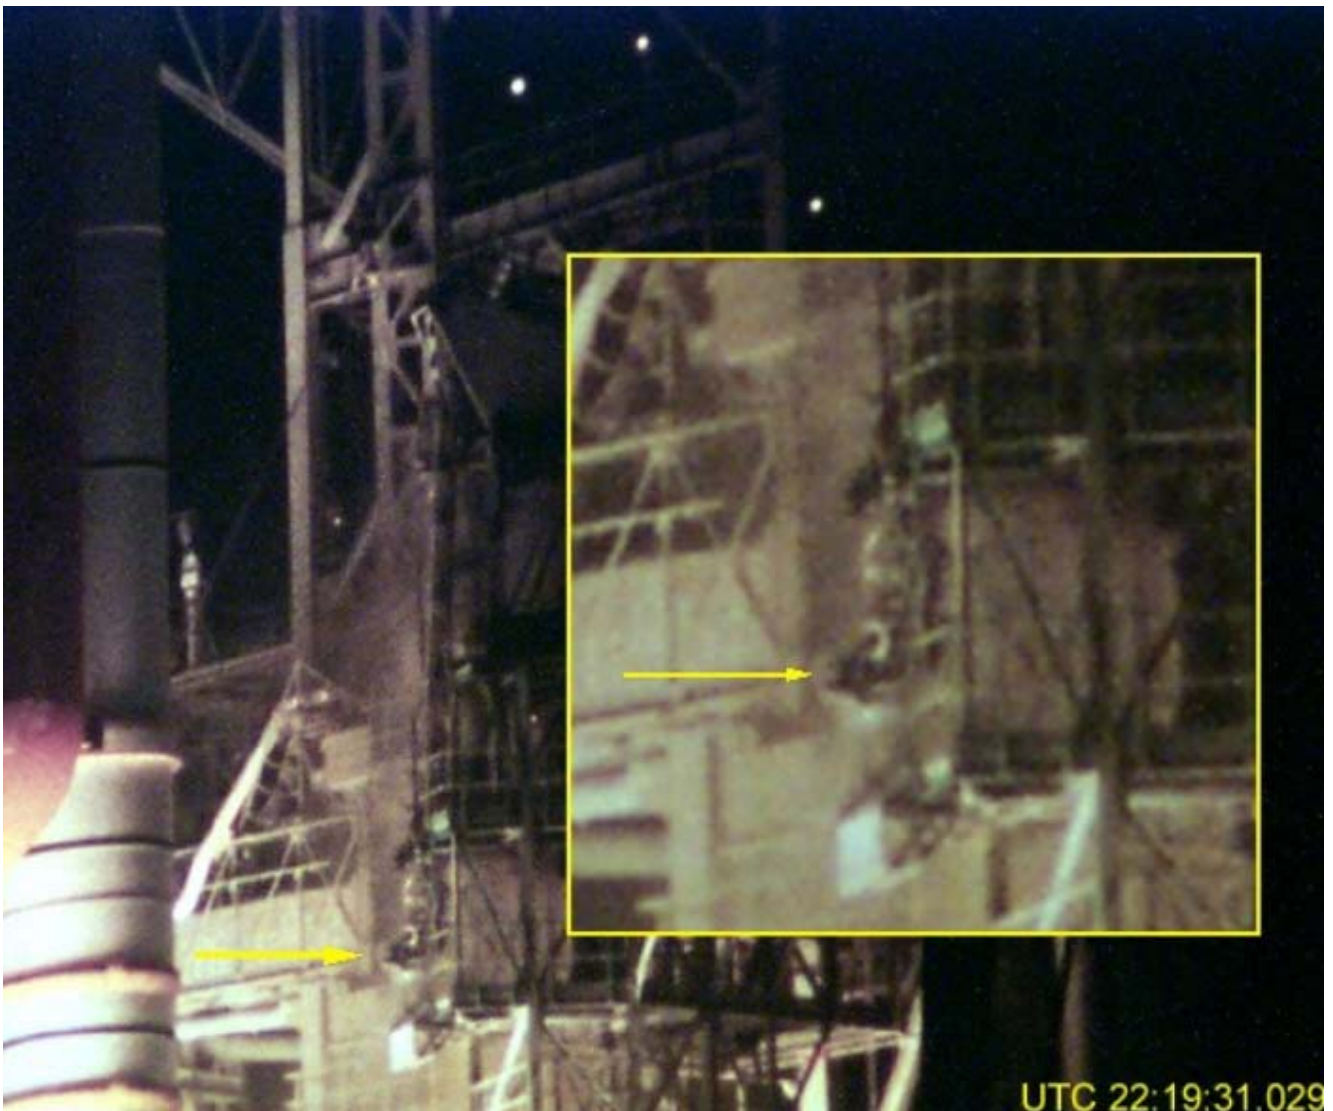
Photo 10: GH2 Vent Line strikes FSS, generating debris, and fails to latch-back.

This view shows the maximum rebound of the vent line.

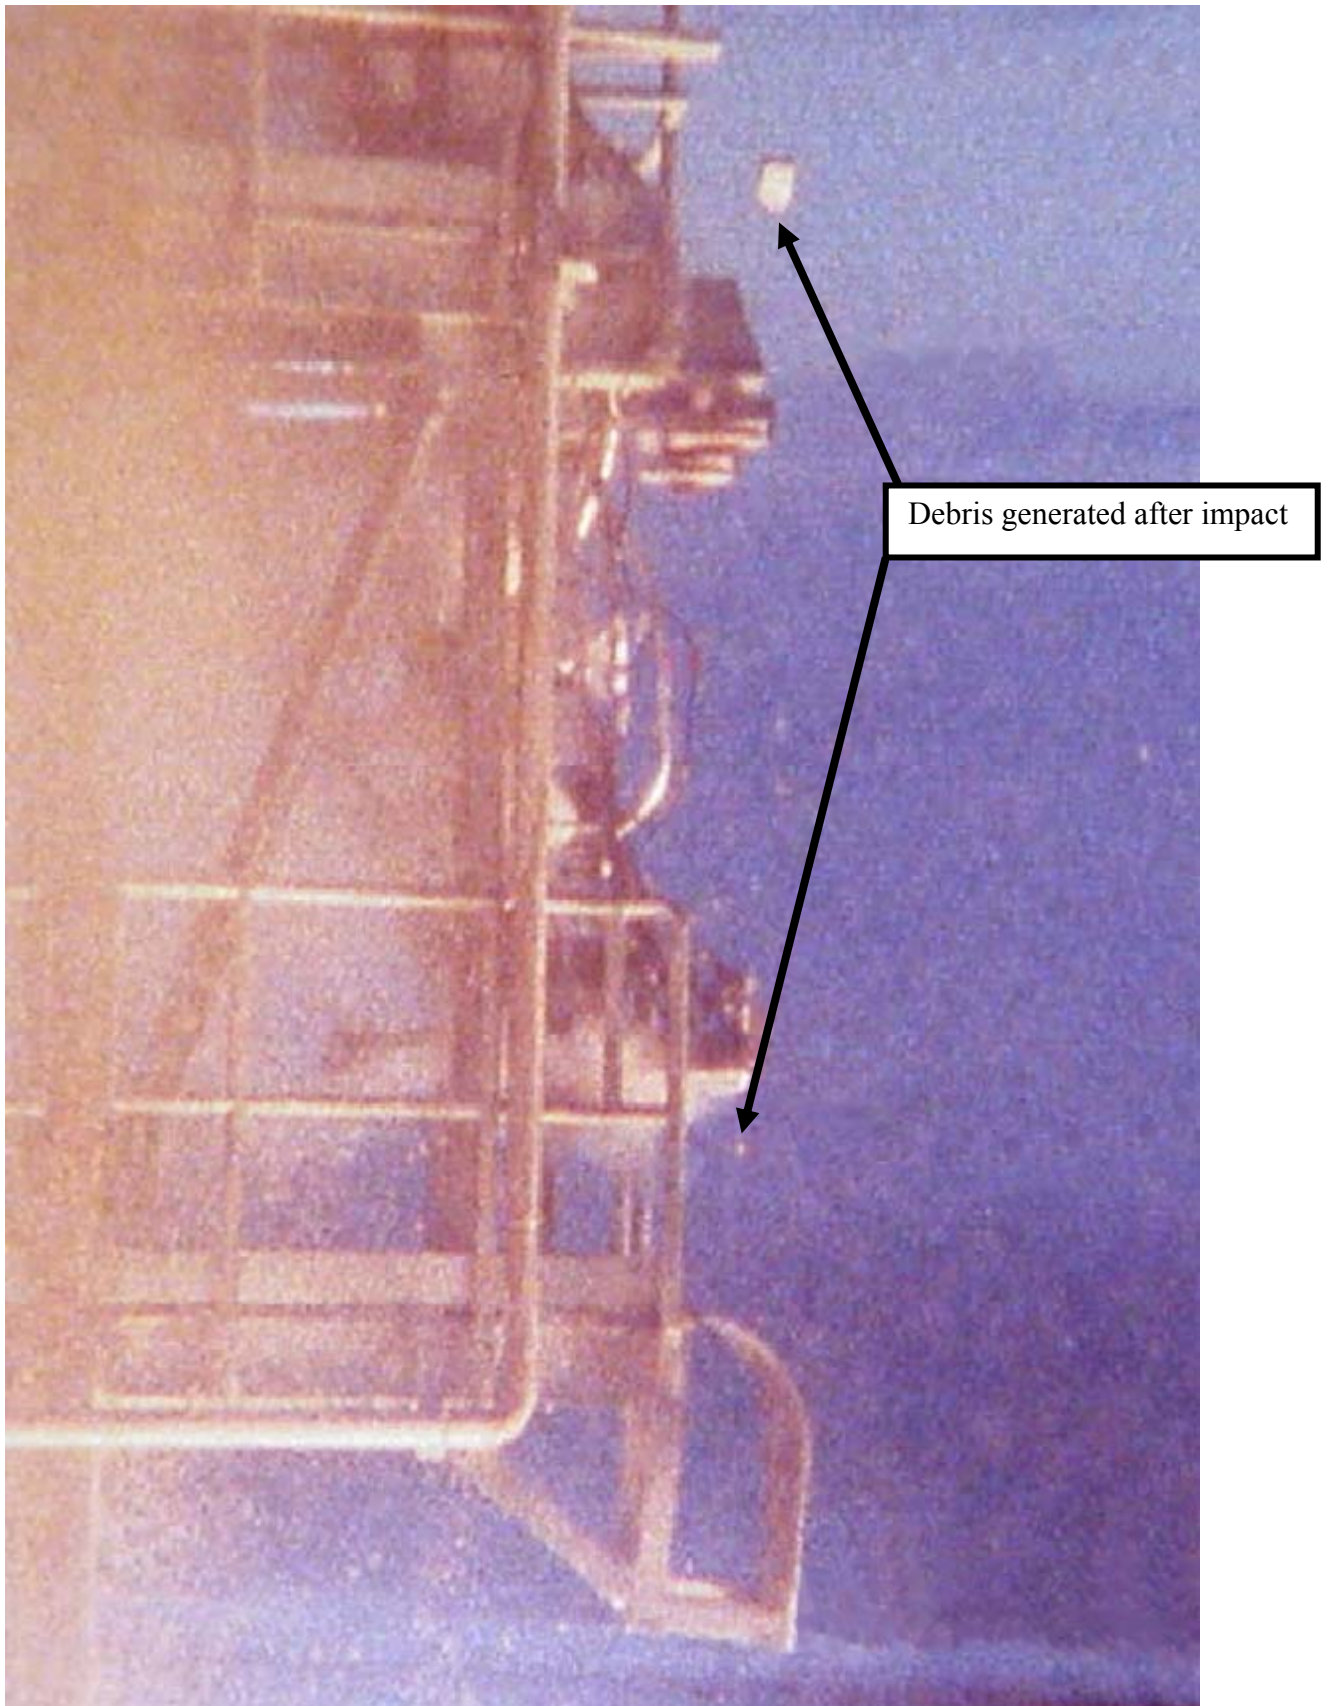
Photo 11: GH2 Vent Line strikes FSS, generating debris, and fails to latch-back.

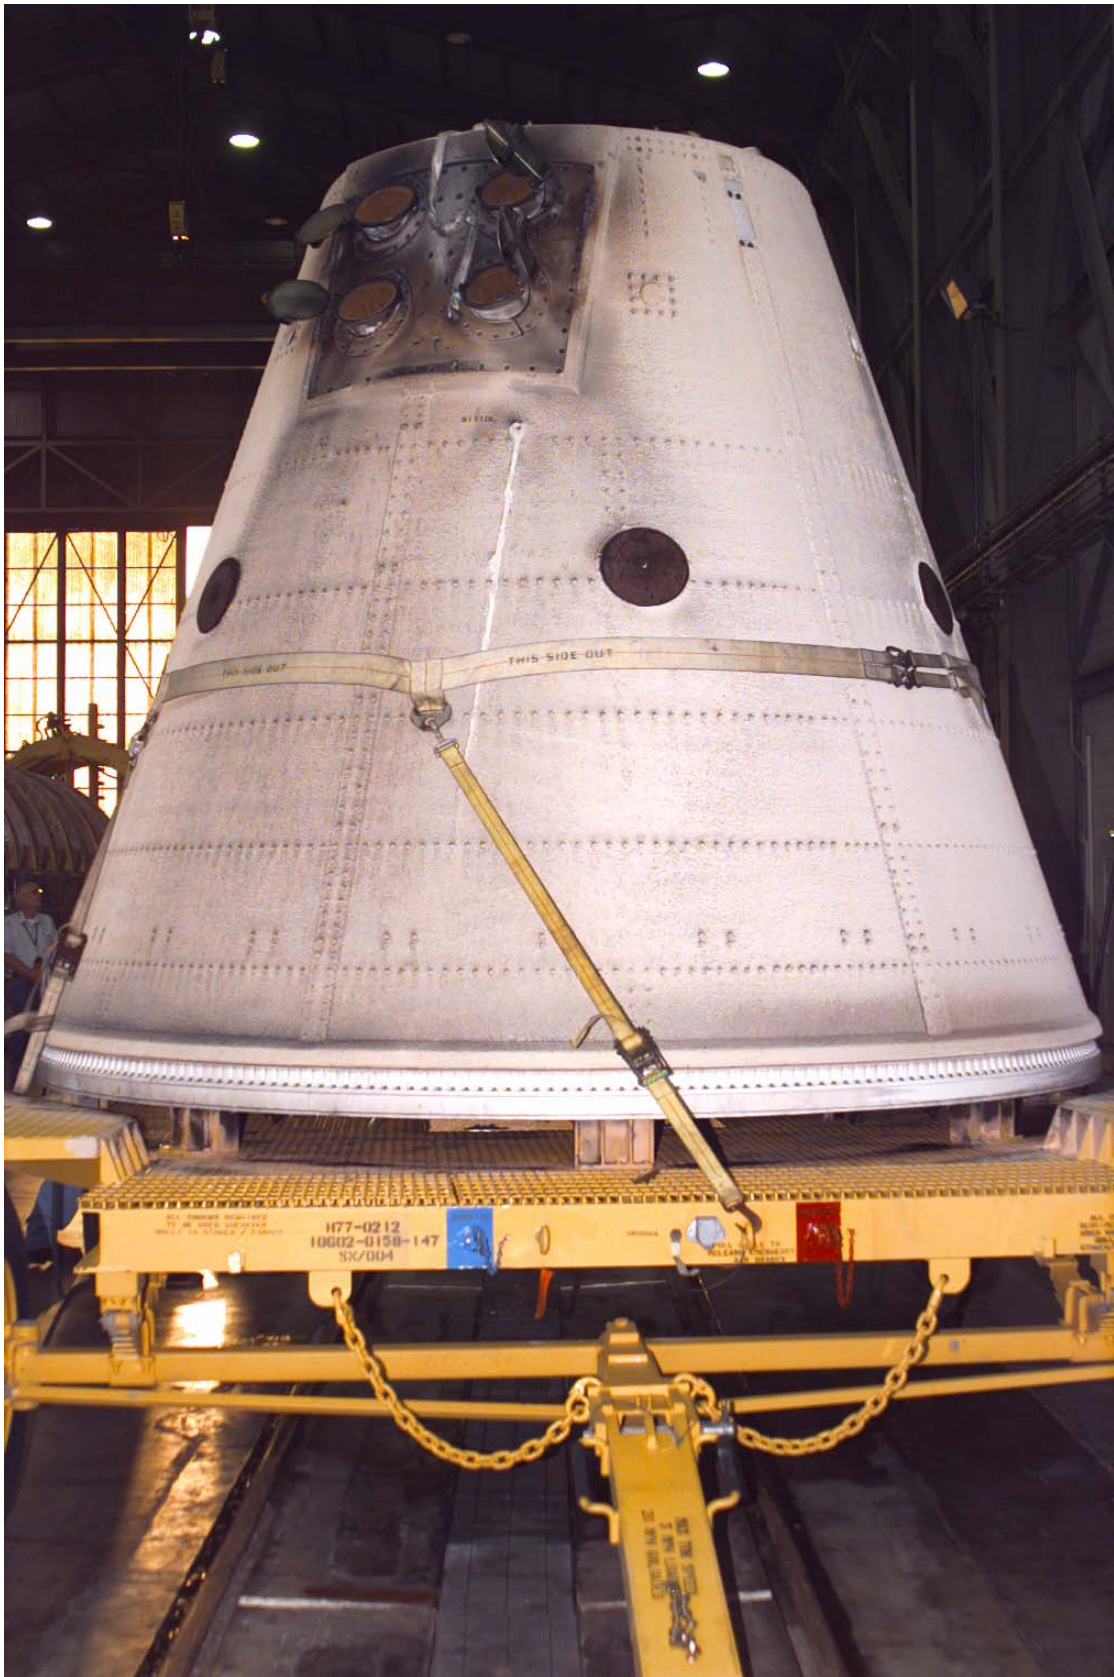
Photo 12: LH Frustum Post Flight Condition

The LH SRB frustum exhibited no debonds/unbonds or missing TPS.

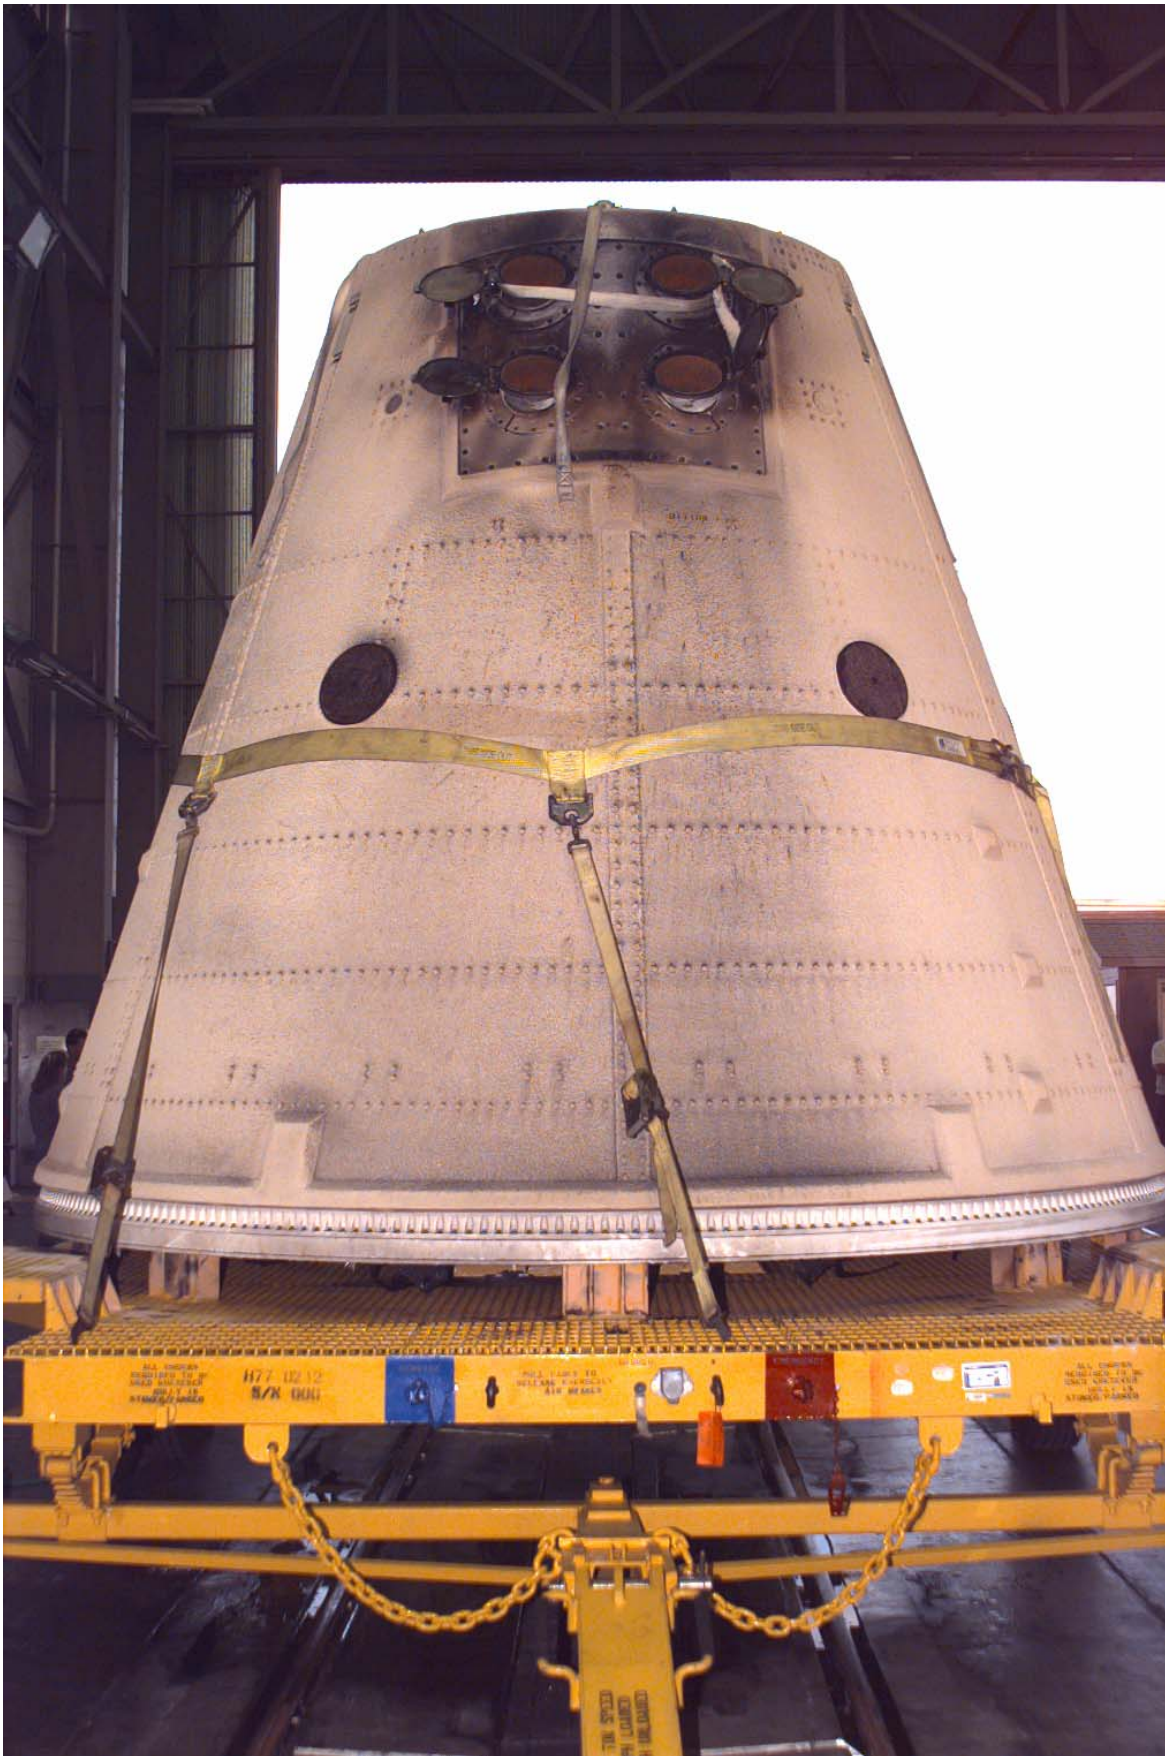
Photo 13: RH Frustum Post Flight Condition

The RH SRB frustum exhibited no debonds/unbonds or missing TPS.
